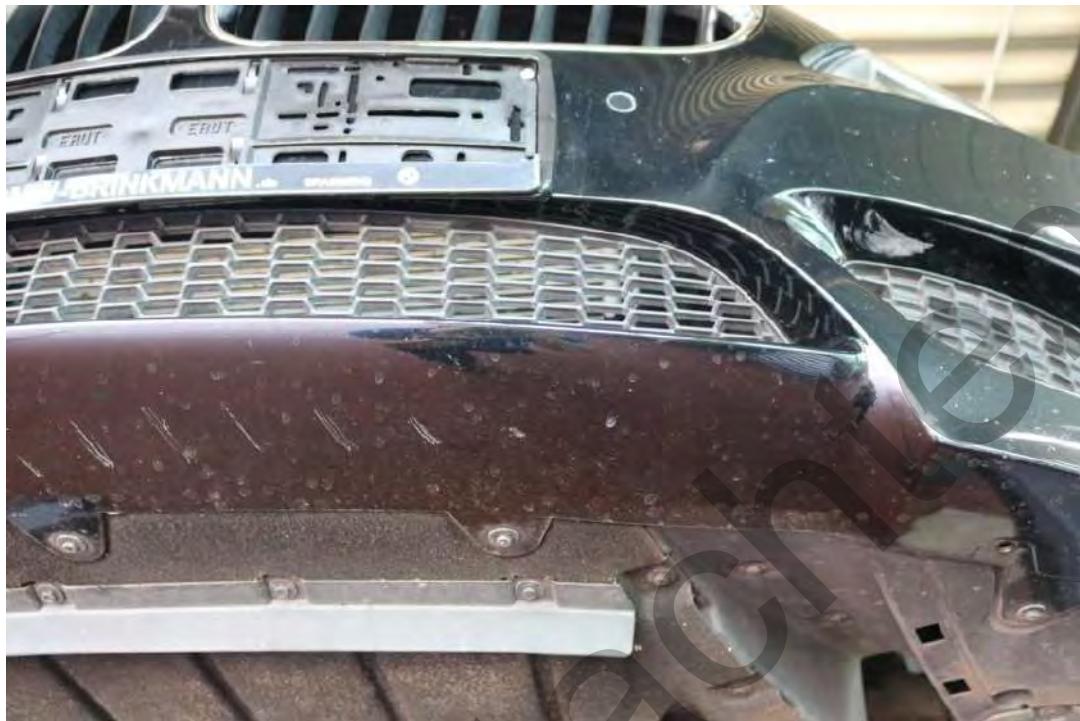
Bild 21: Mangel / Schaden – Karosserie Sicht - Stoßfänger vorn, leicht geschürft; leichter Steinschlag

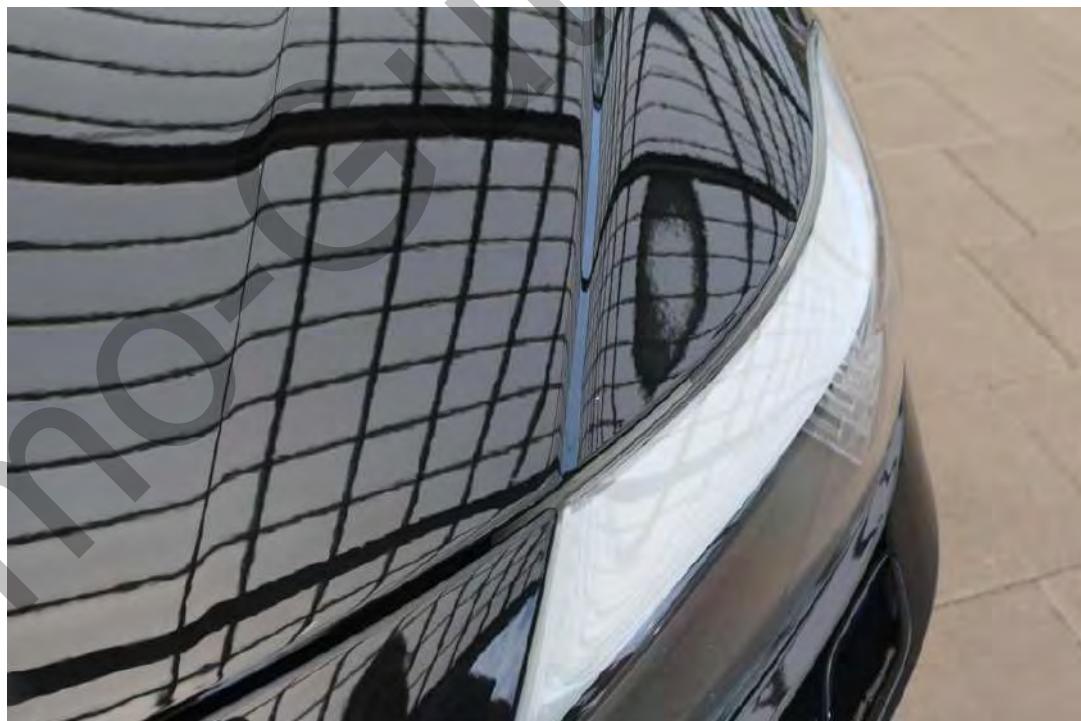
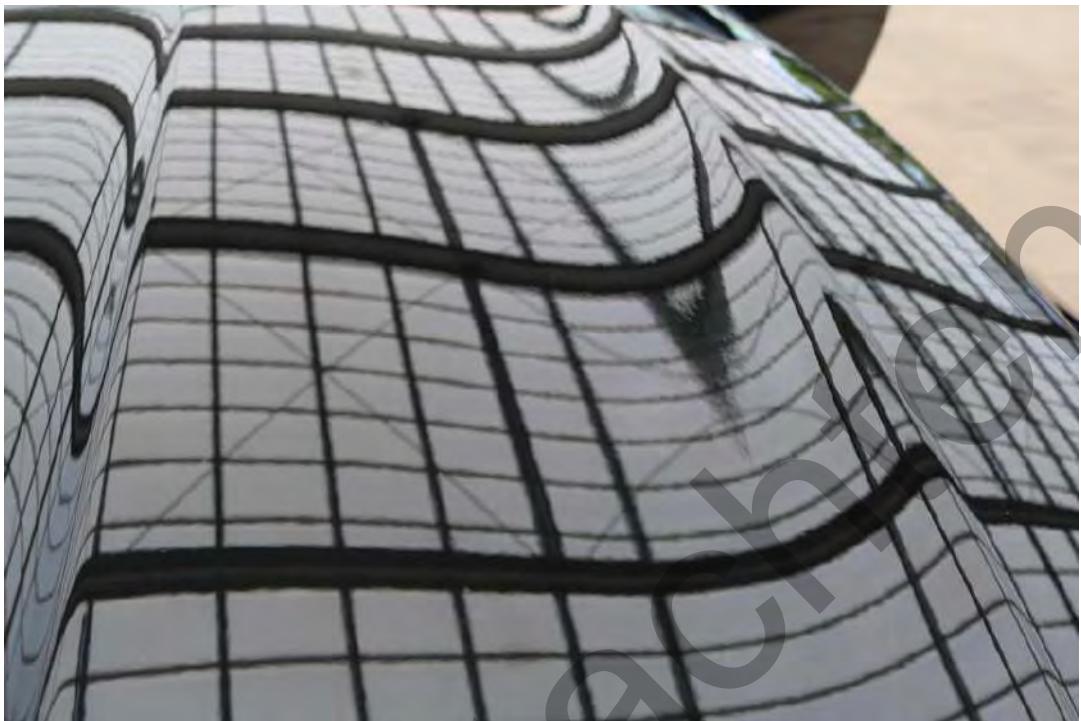
Bild 34: Mangel / Schaden – Karosserie Sicht - Motorhaube, Steinschlag; leichter Kratzer (poliert)

Bild 35: Mangel / Schaden – Karosserie Sicht - Motorhaube, Steinschlag; leichter Kratzer (poliert)

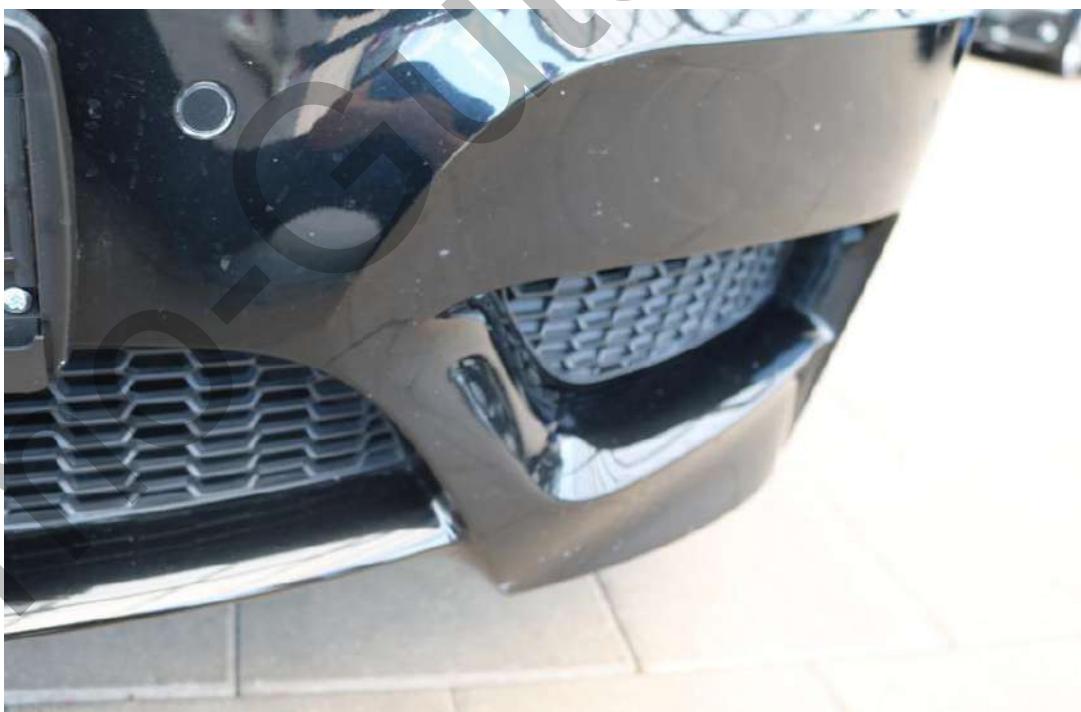
Bild 36: Mangel / Schaden – Karosserie Sicht - Stoßfänger vorn, leicht geschürft; leichter Steinschlag

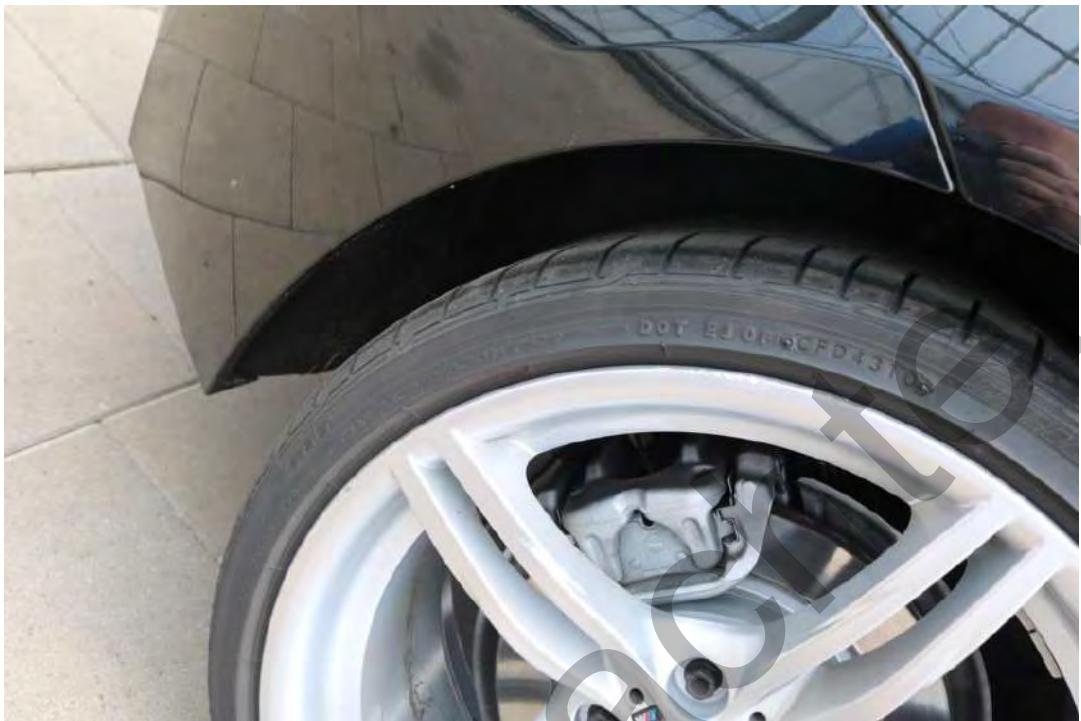
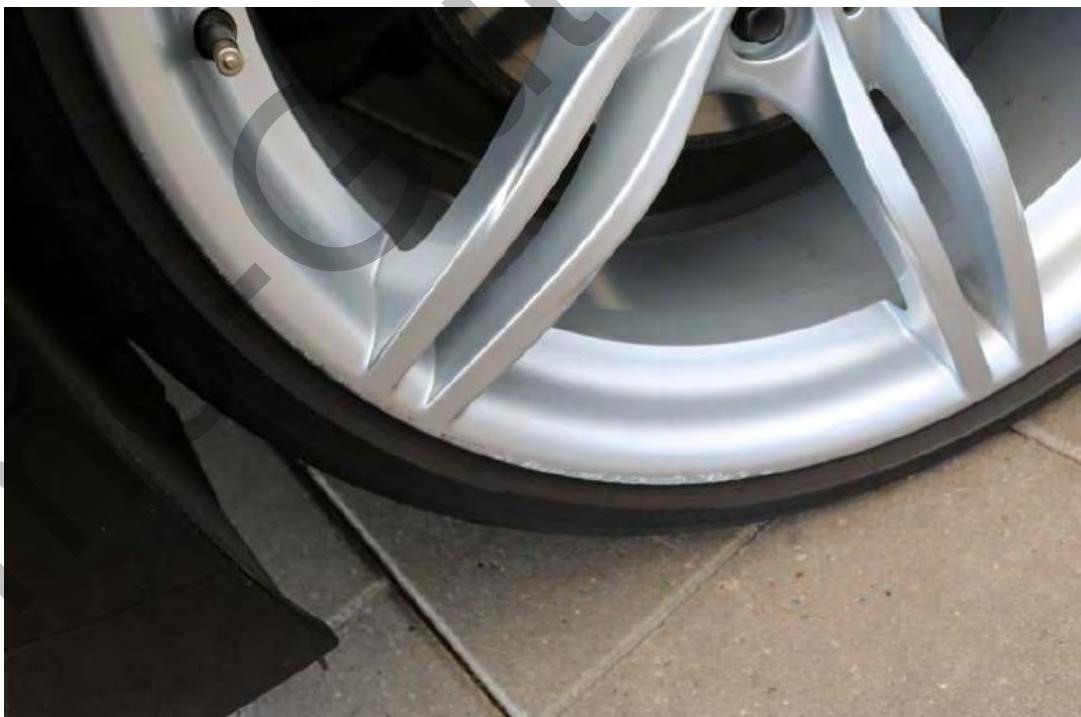
Bild 37: Mangel / Schaden – Außen - Felgen, VR, VL, HR geschürft

Bild 38: Mangel / Schaden – Außen - Felgen, VR, VL, HR geschürft
