| vehicle | | | | | |
|---|---|---|---|---|---|
| vehicle identification number (VIN) | WBALM31000E4546 | producer | BMW | model | Z4 |

| Conclusion of the expert: |

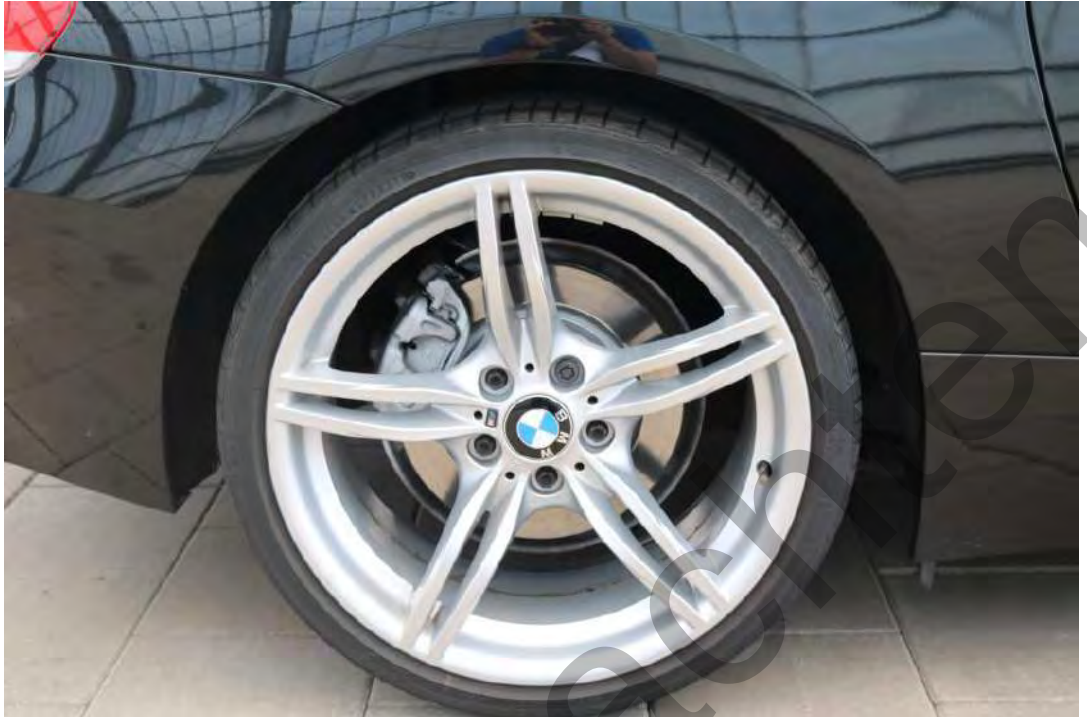
Bild 9: Felge und Reifen h. r.

| tires | producer | usage | size | profile thickness in mm | remark |
|---|---|---|---|---|---|
| ● back right mounted | Bridgestone Potenza | summer tyres | 225/35 R 19 88Y | 6,0 | porous |

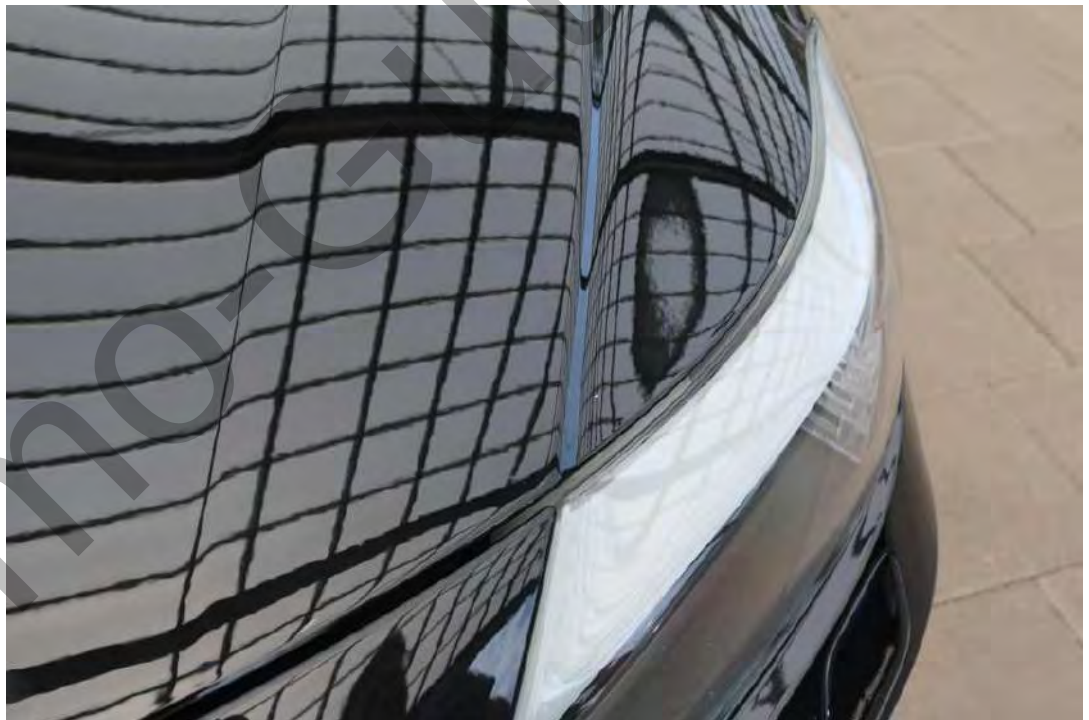
| paint thickness | paint layer thickness in µm | condition |
|---|---|---|
| ● engine bonnet | 135 | stone chipping |

| <input checked="" type="radio"/> engine bonnet | Steinschlag; leichter Kratzer (poliert) |

Bild 34: Mangel / Schaden – Karosserie Sicht - Motorhaube, Steinschlag; leichter Kratzer (poliert)

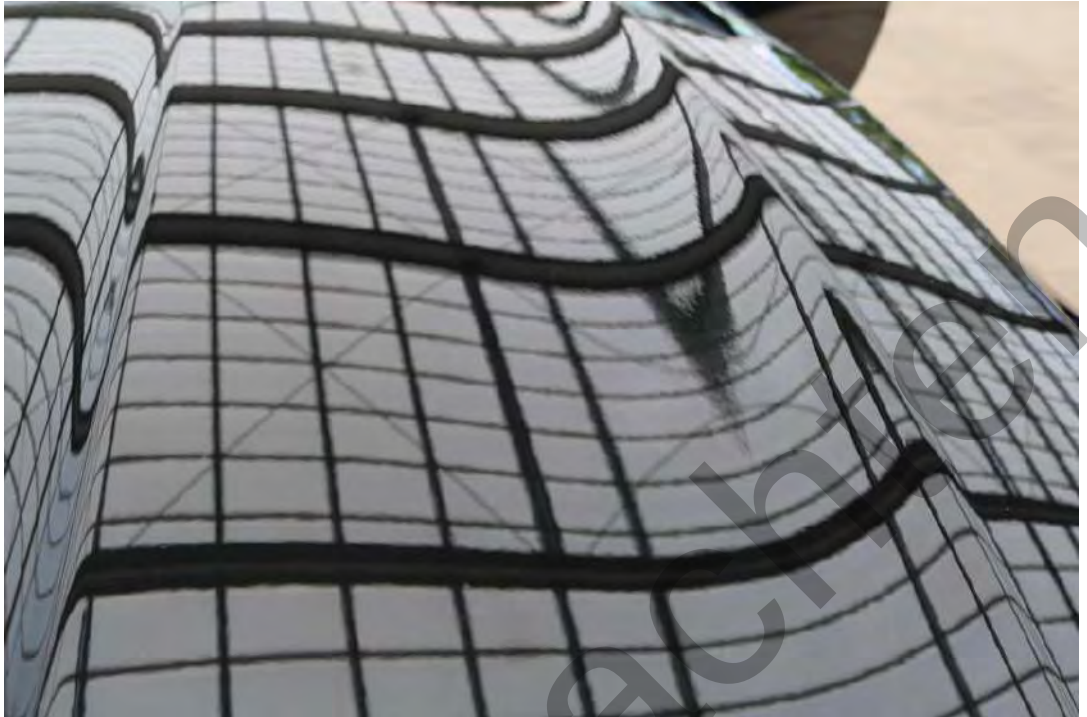
Bild 35: Mangel / Schaden – Karosserie Sicht - Motorhaube, Steinschlag; leichter Kratzer (poliert)

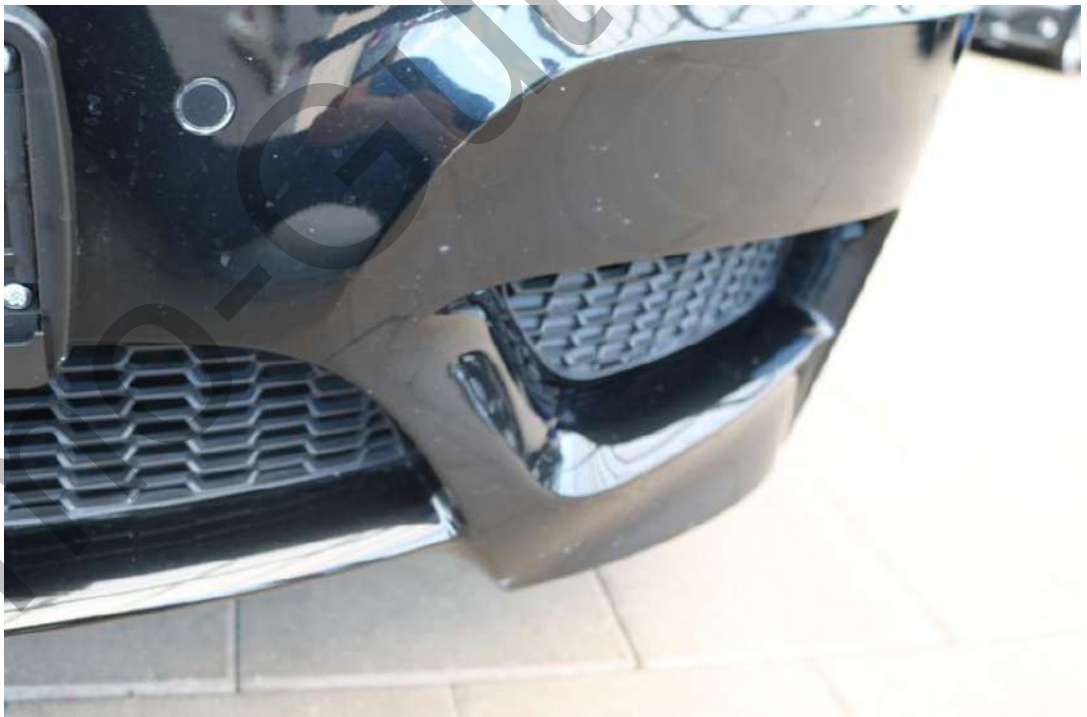
| <input checked="" type="radio"/> front bumpers | leicht geschürft; leichter Steinschlag |

Bild 36: Mangel / Schaden – Karosserie Sicht - Stoßfänger vorn, leicht geschürft; leichter Steinschlag

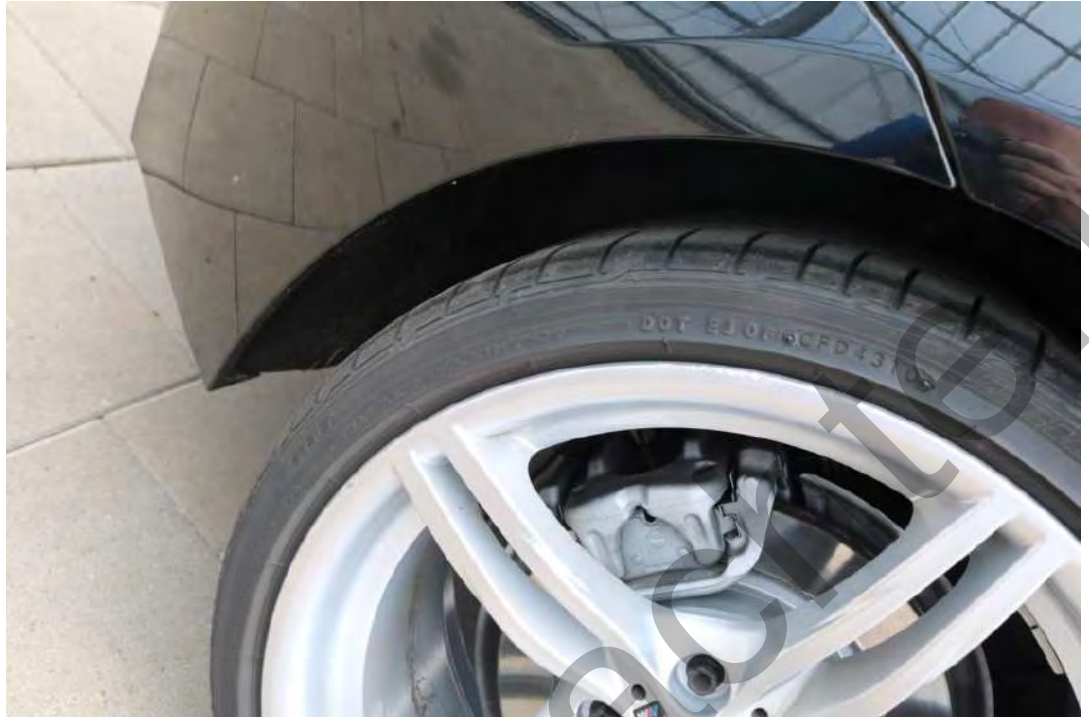
| <input checked="" type="radio"/> rims | VR, VL, HR geschürft |

Bild 37: Mangel / Schaden – Außen - Felgen, VR, VL, HR geschürft

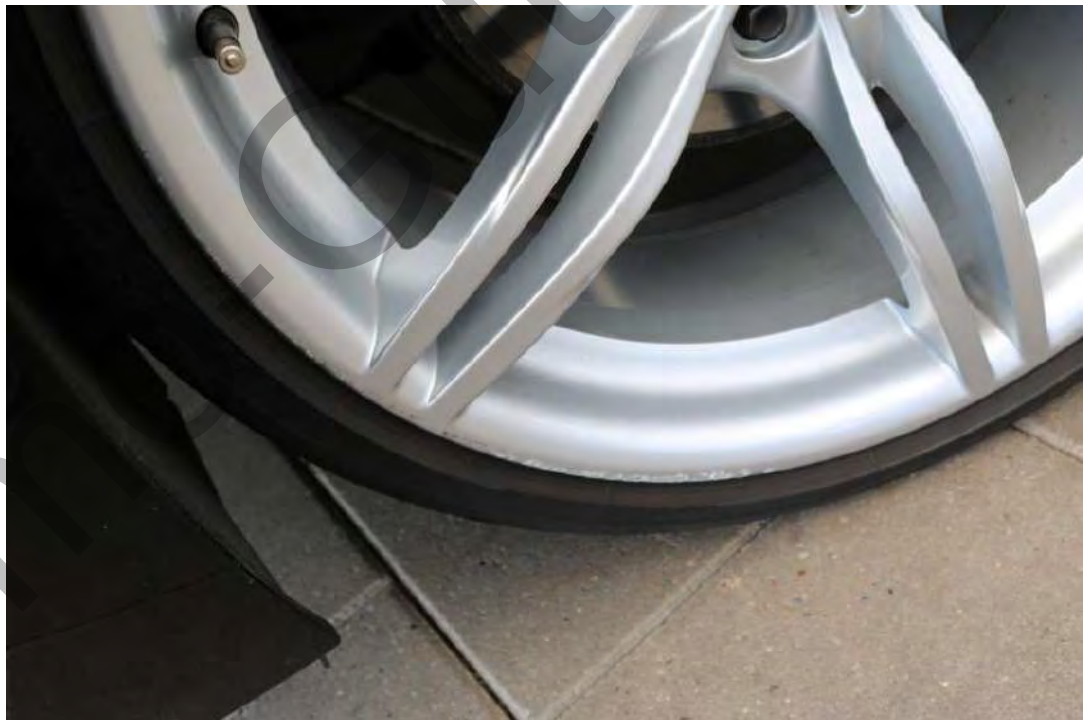
Bild 38: Mangel / Schaden – Außen - Felgen, VR, VL, HR geschürft
