| vehicle | | | | | |
|---|---|---|---|---|---|
| vehicle identification number/ VIN | 11603612016857 | producer | Mercedes-Benz | model | 450SEL |

Das Gutachten wurde am 23.04.2020 um 10:30 Uhr erstellt.

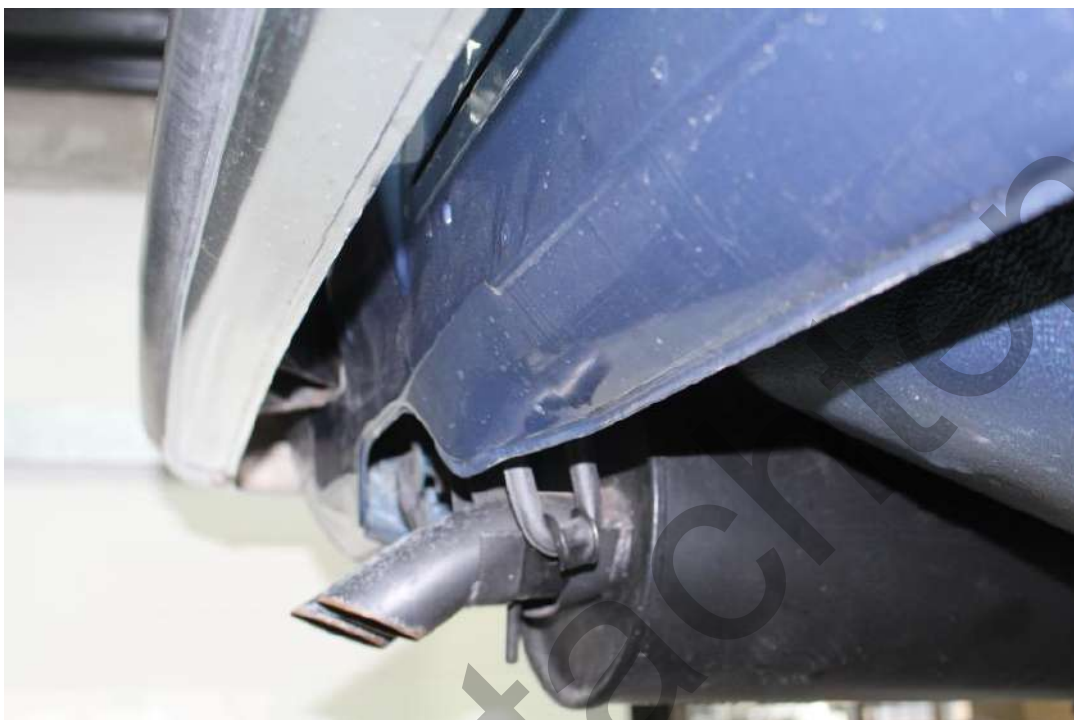
Bild 1: Heck – Heckabschlussblech deformiert

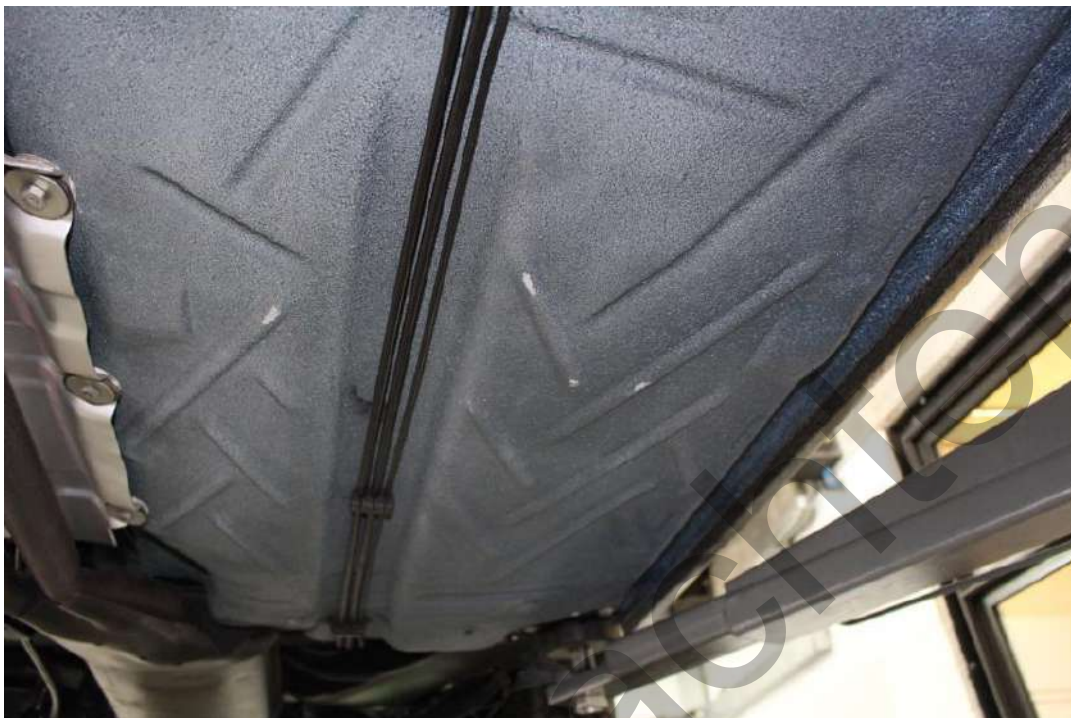
Bild 19: Unterboden – leichte Abschürfung Unterbodenschutz

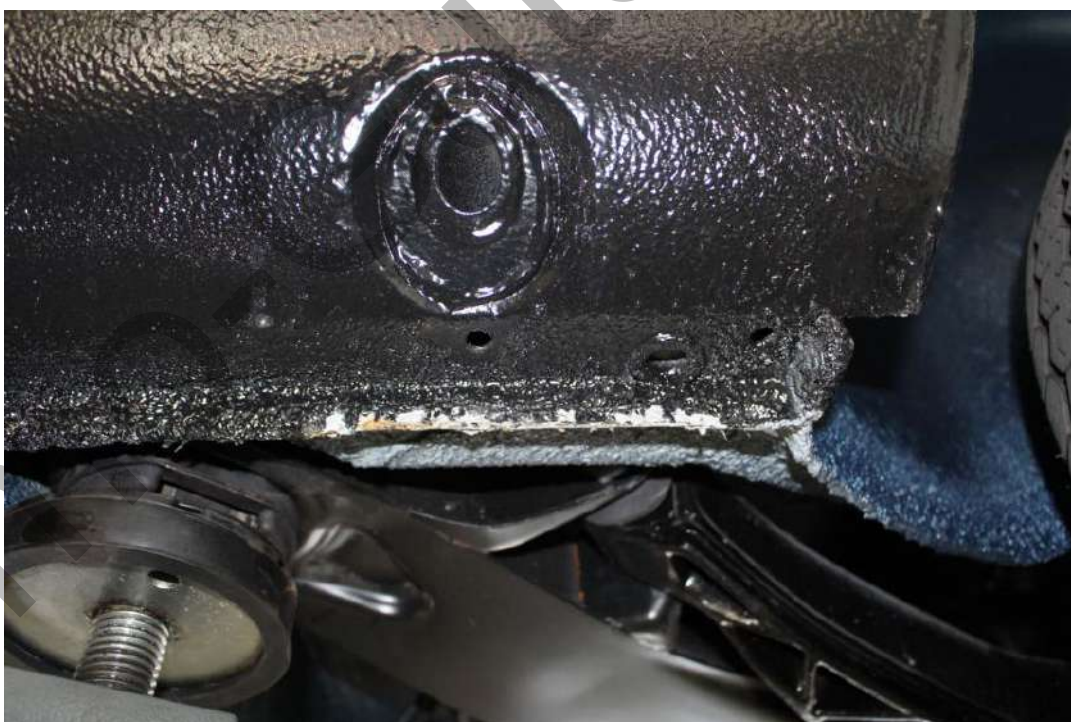
Bild 20: Unterboden – Abschürfung Unterbodenschutz Wagenheberaufnahmen

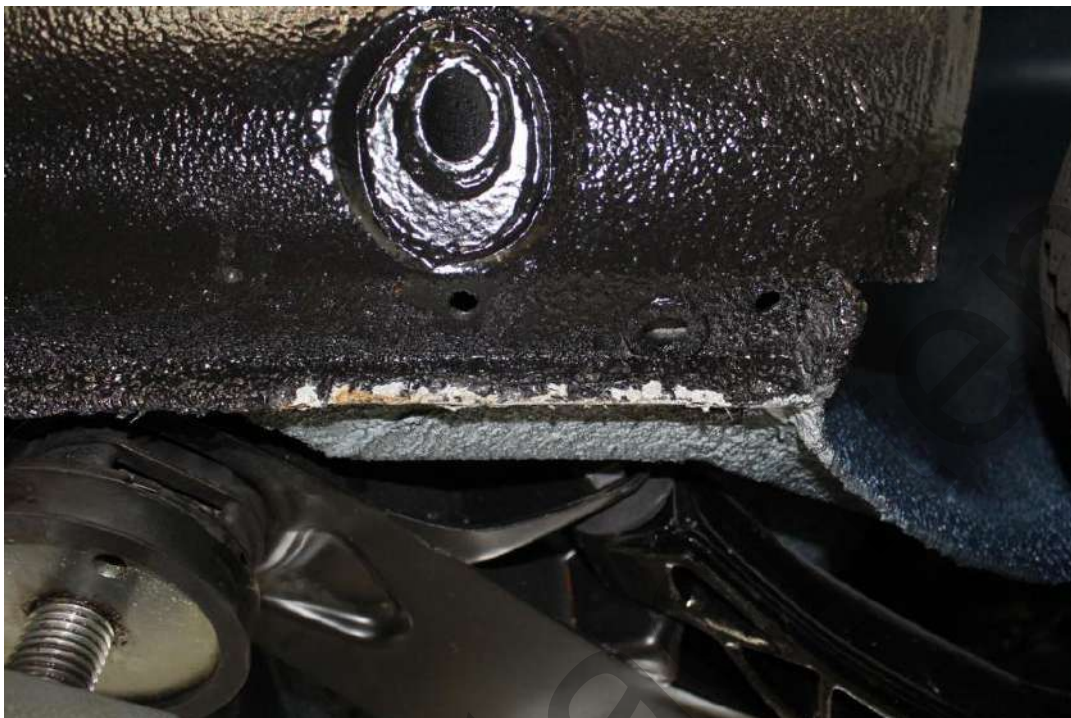
Bild 21: Unterboden – Abschürfung Unterbodenschutz Wagenheberaufnahmen

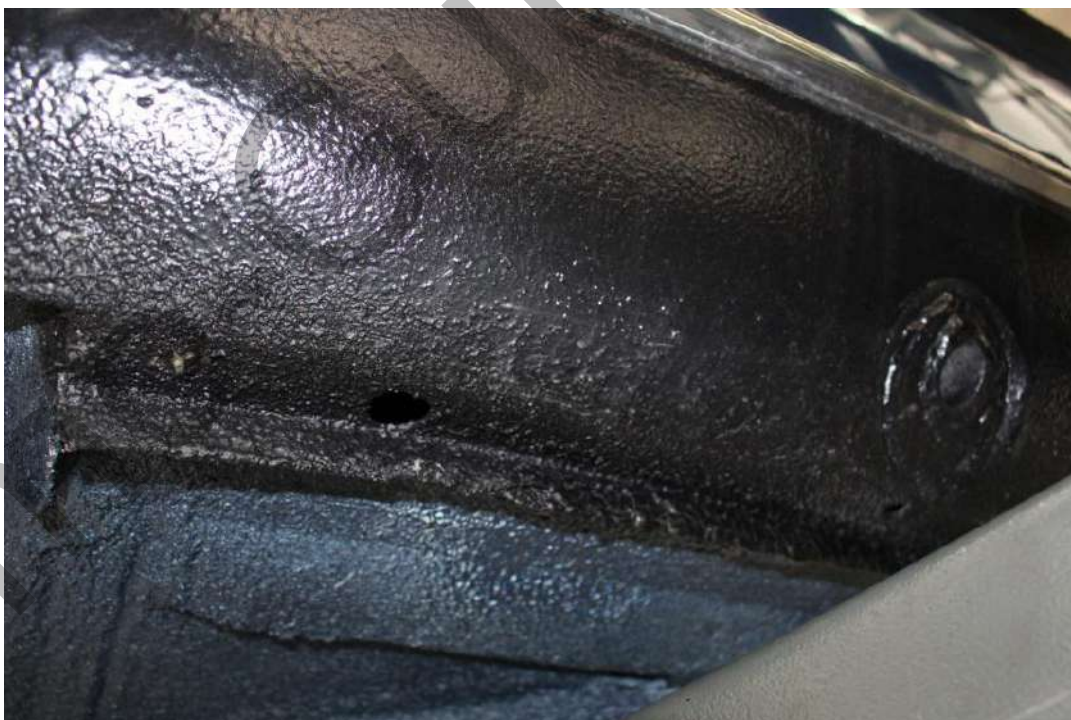
Bild 22: Unterboden – Abschürfung Unterbodenschutz Wagenheberaufnahmen

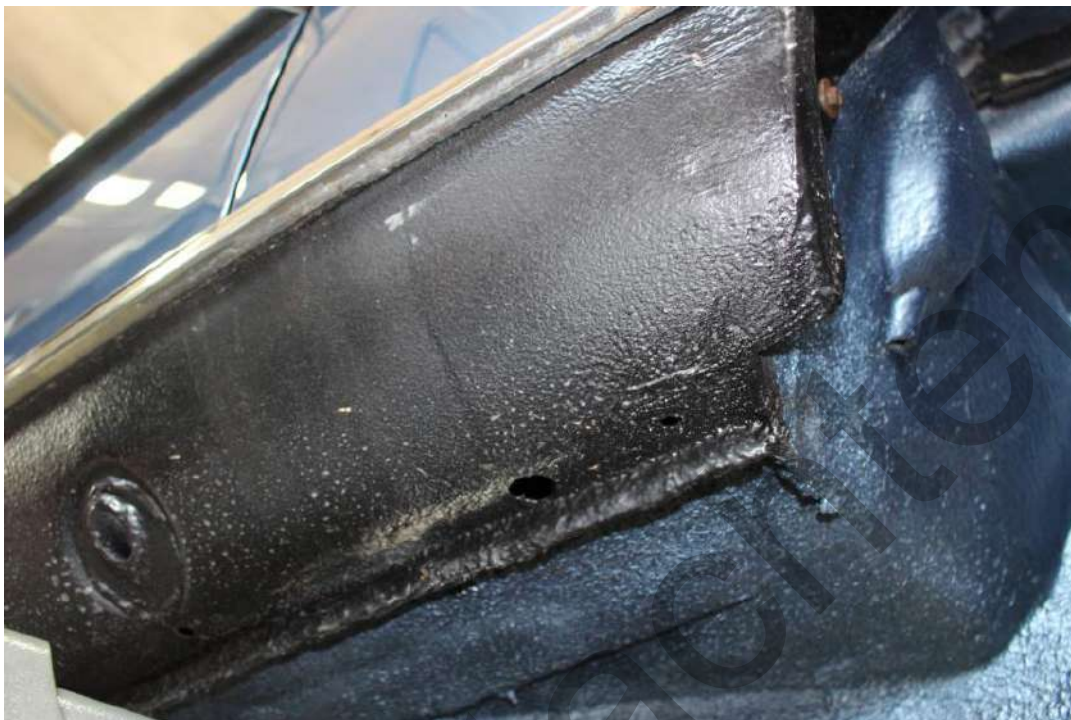
Bild 23: Unterboden – Abschürfung Unterbodenschutz Wagenheberaufnahmen

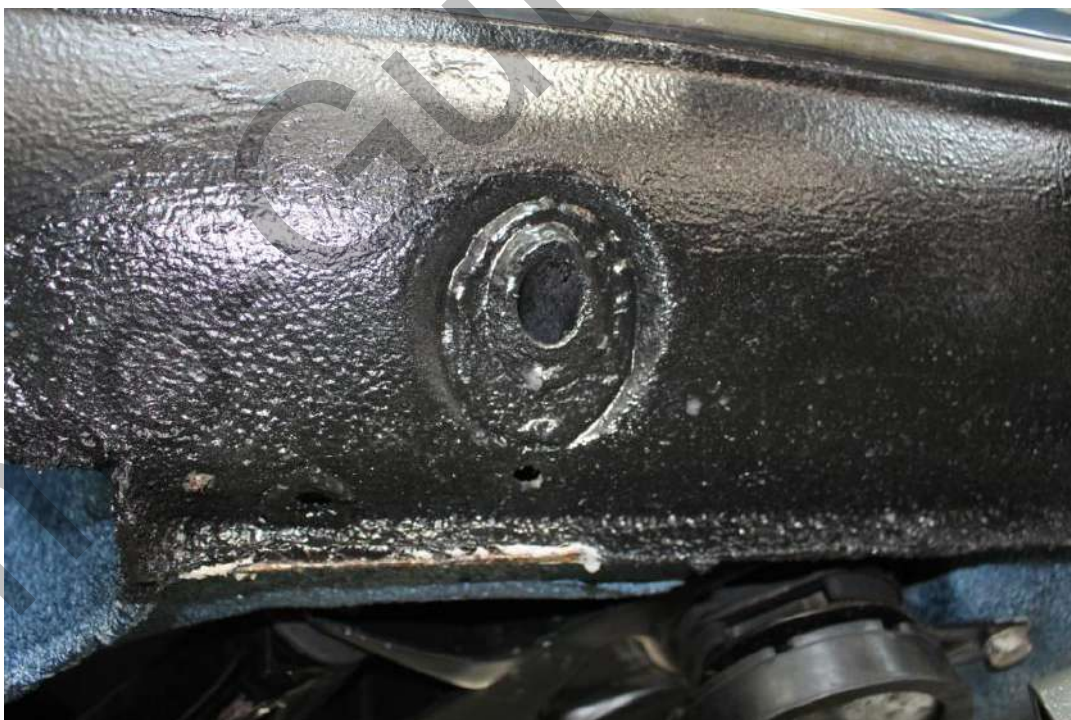
Bild 24: Unterboden – Abschürfung Unterbodenschutz Wagenheberaufnahmen

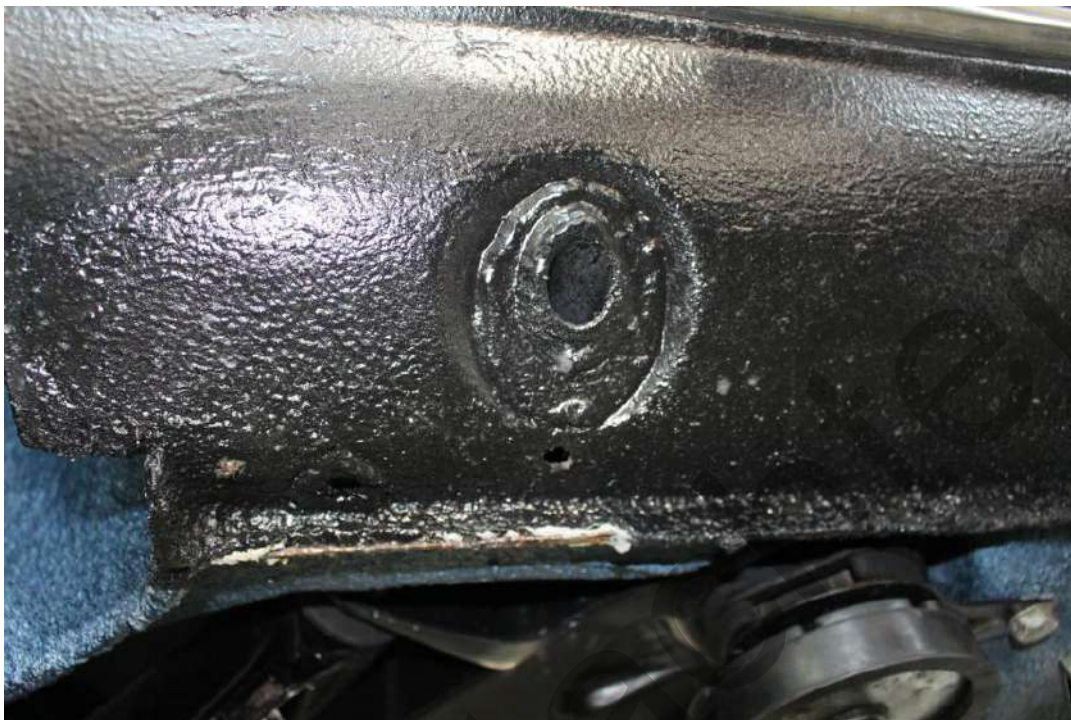
Bild 25: Unterboden – Abschürfung Unterbodenschutz Wagenheberaufnahmen

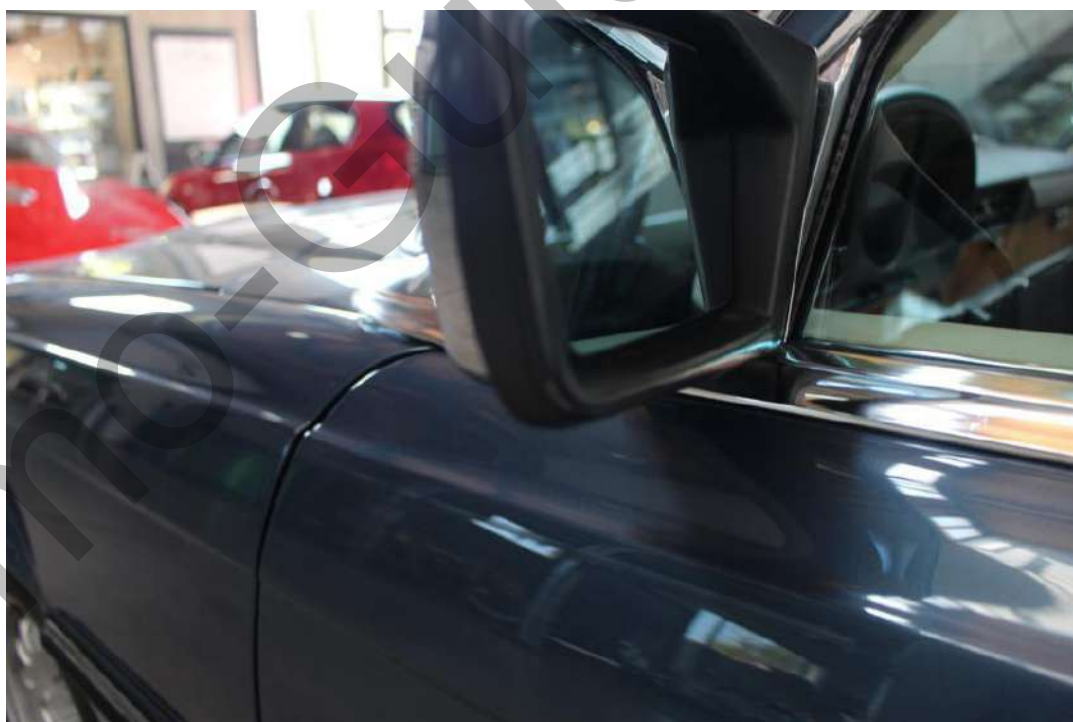
Bild 52: Mangel / Schaden – Außen - Anbauteile, Aussenspiegel links geschürft

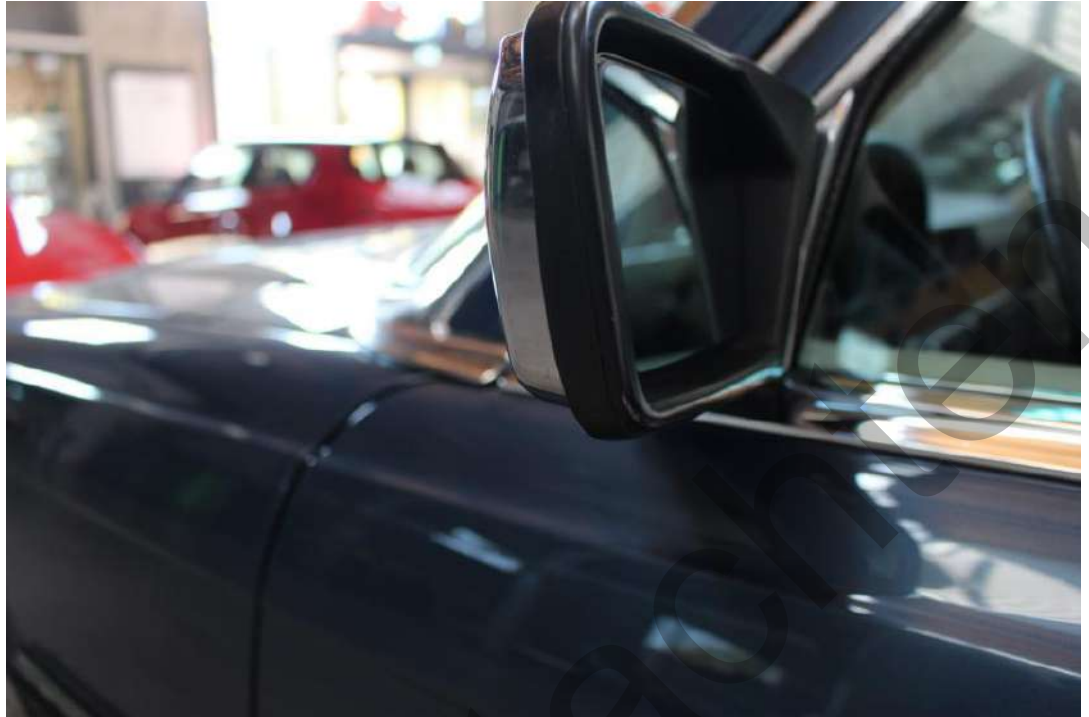
Bild 53: Aussenspiegel links geschürt

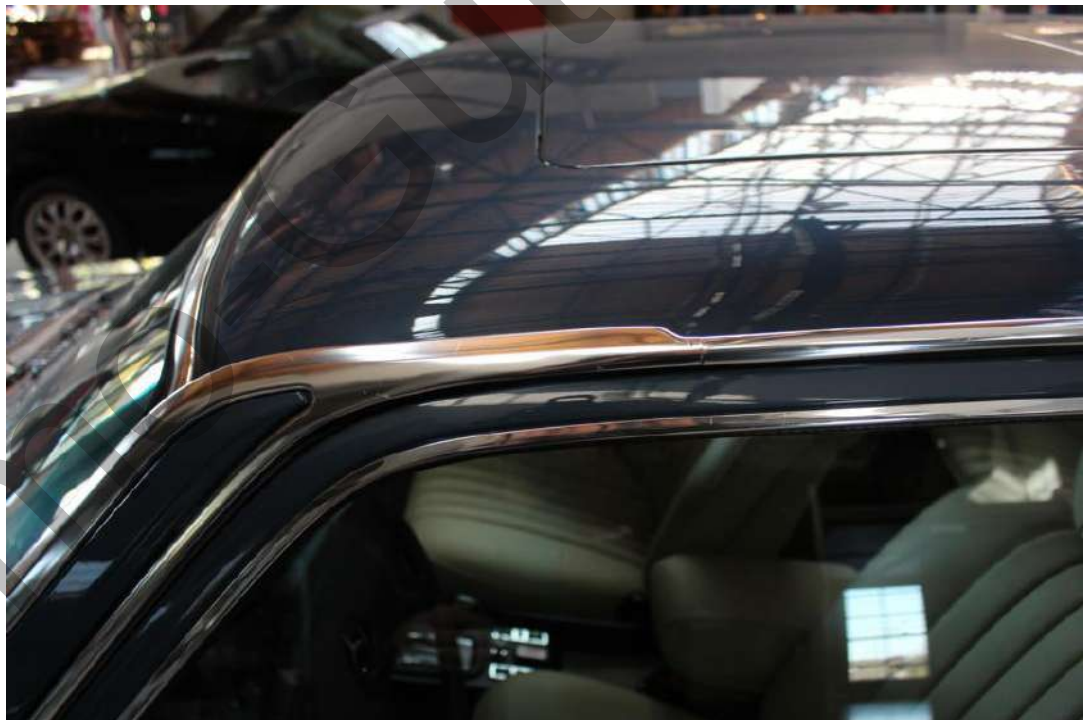
Bild 54: Dach – Kratzer

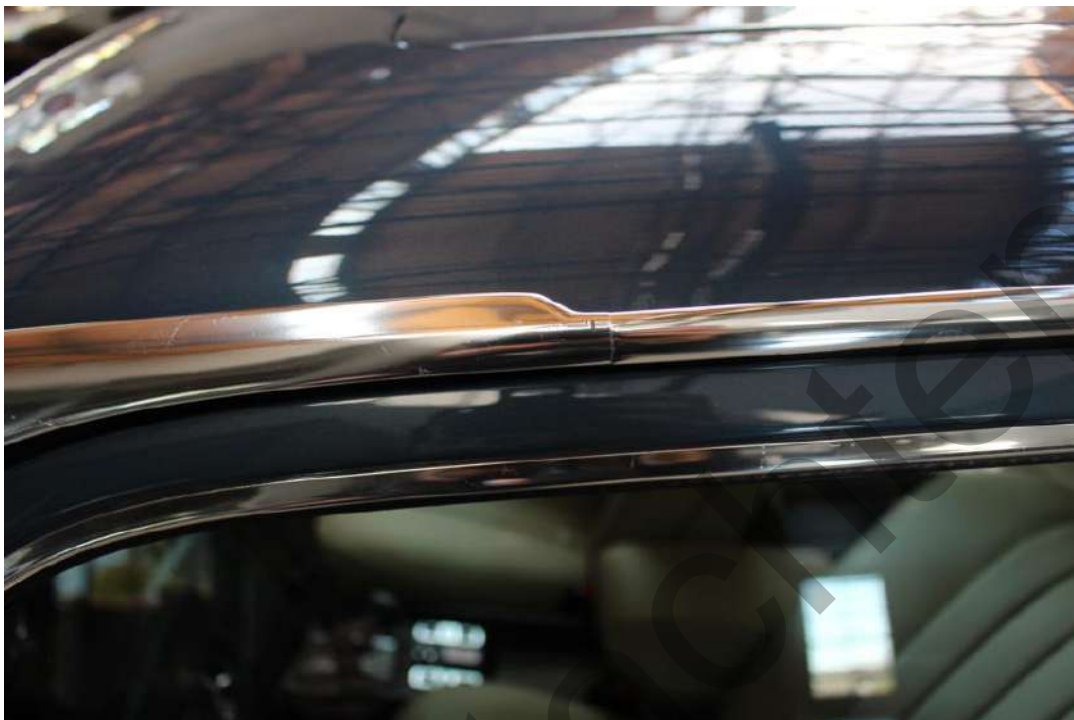
Bild 55: Dach – Kratzer

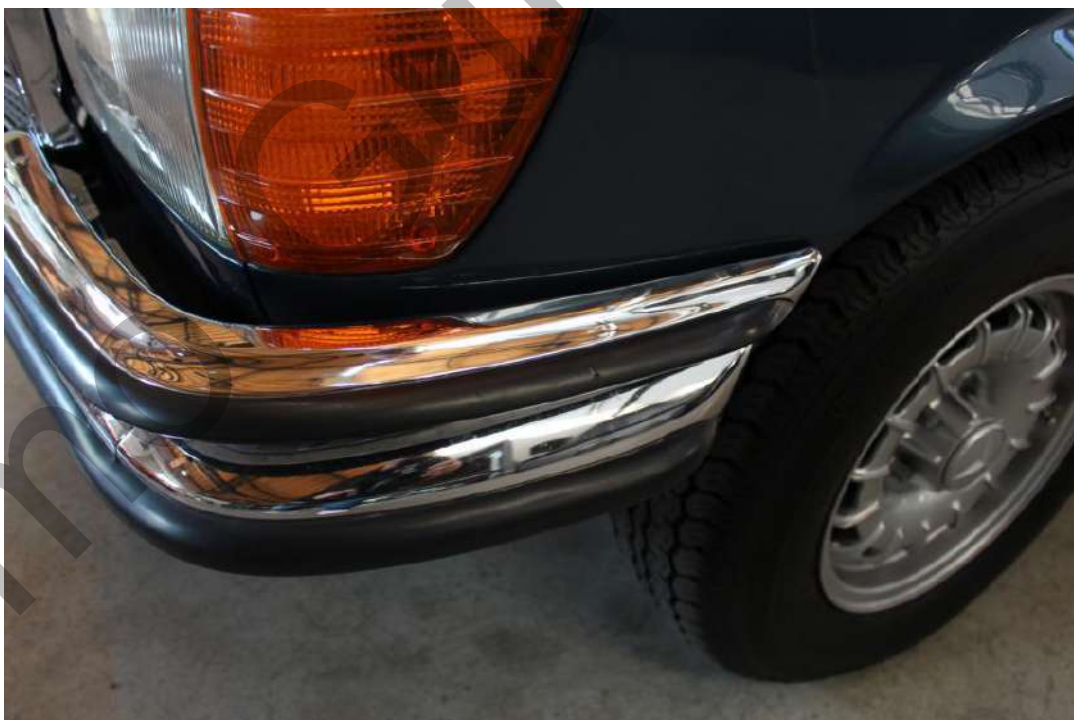
Bild 56: Front – Gebrauchsspuren

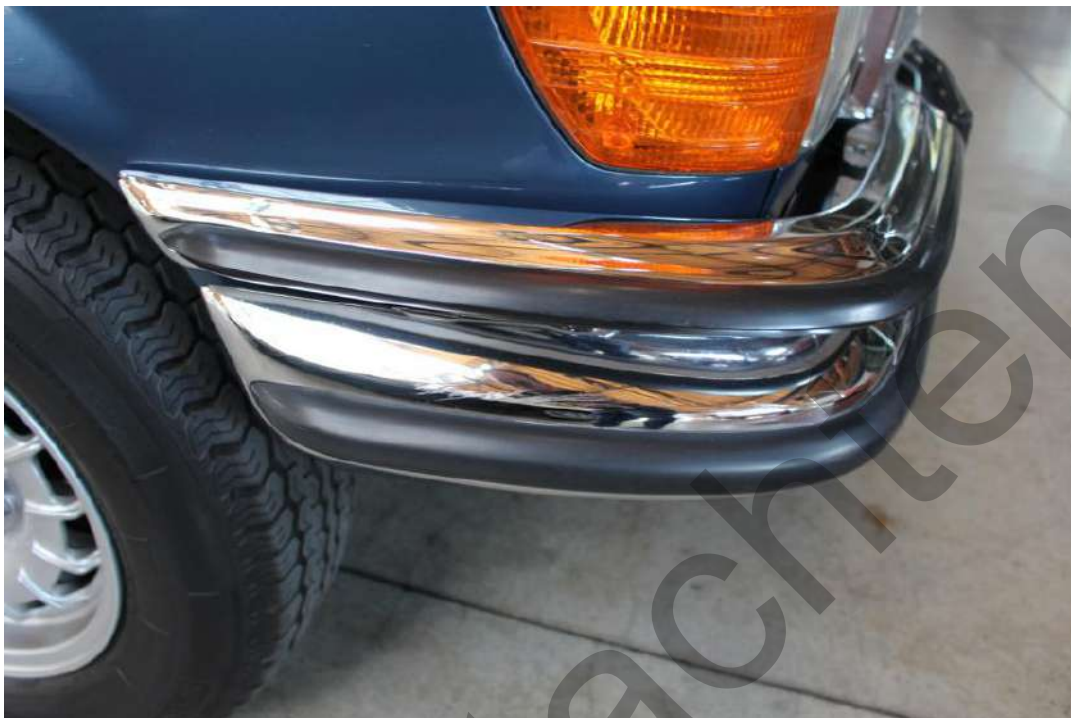
| state of the vehicle at the time of inspection - exterior | |
|---|---|
| attached parts | Stossleisten mit Gebrauchsspuren |

Bild 57: Mangel / Schaden – Außen - Anbauteile, Gebrauchsspuren

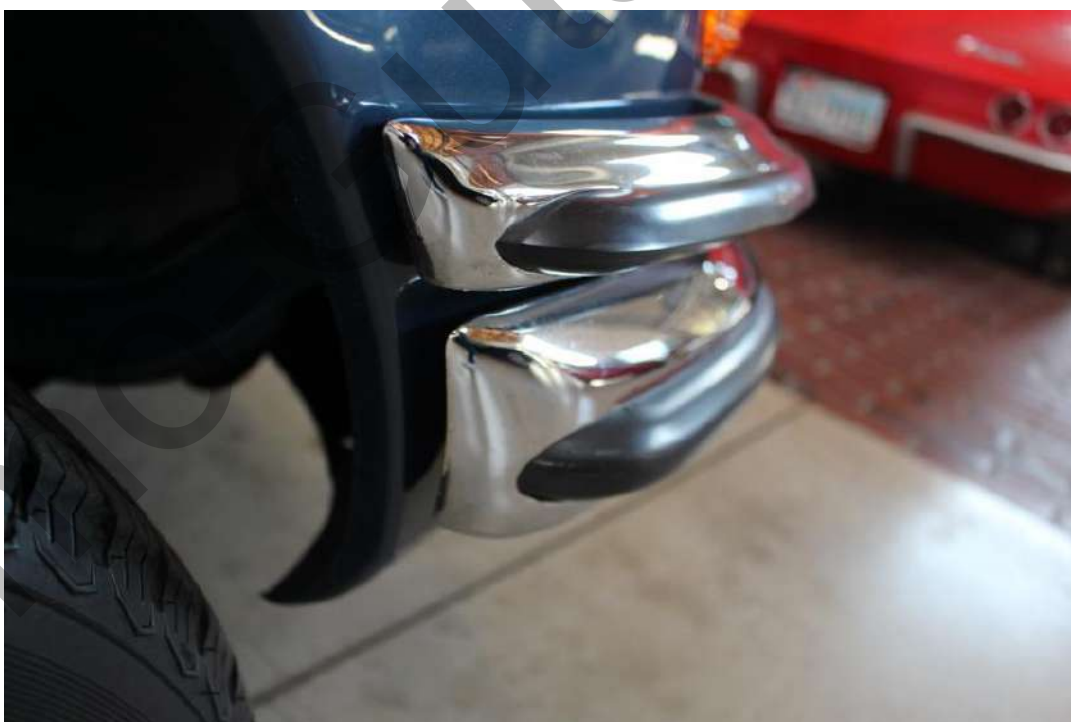
Bild 58: Mangel / Schaden – Außen - Anbauteile, Stossleisten mit Gebrauchsspuren

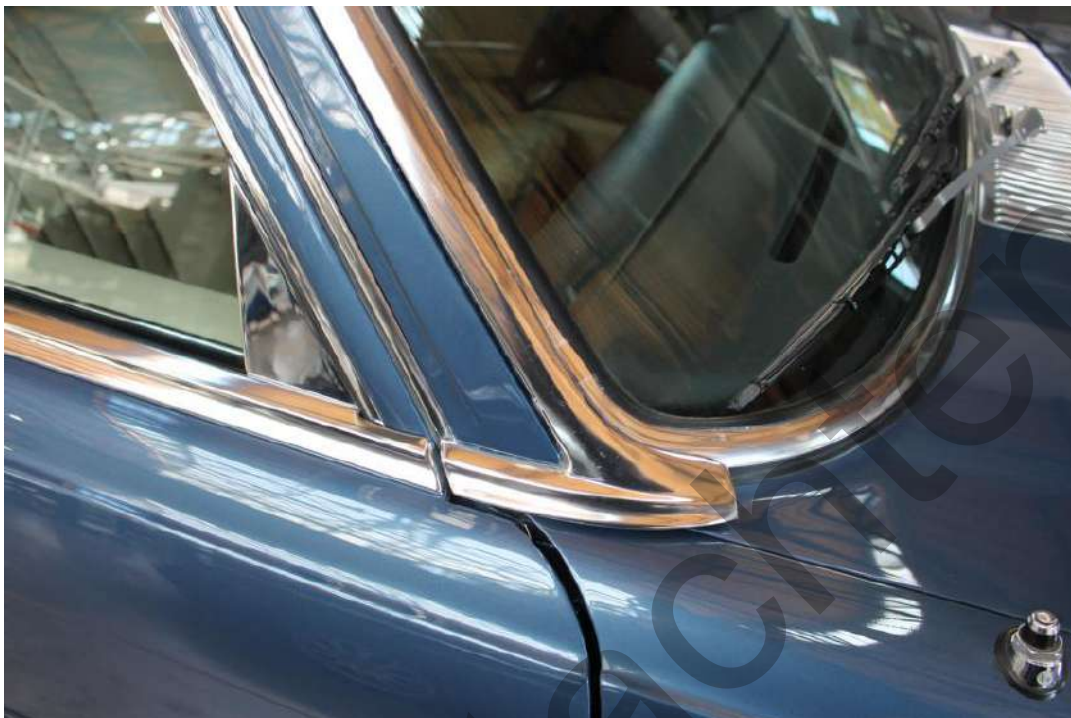
Bild 59: Front – Gebrauchsspuren

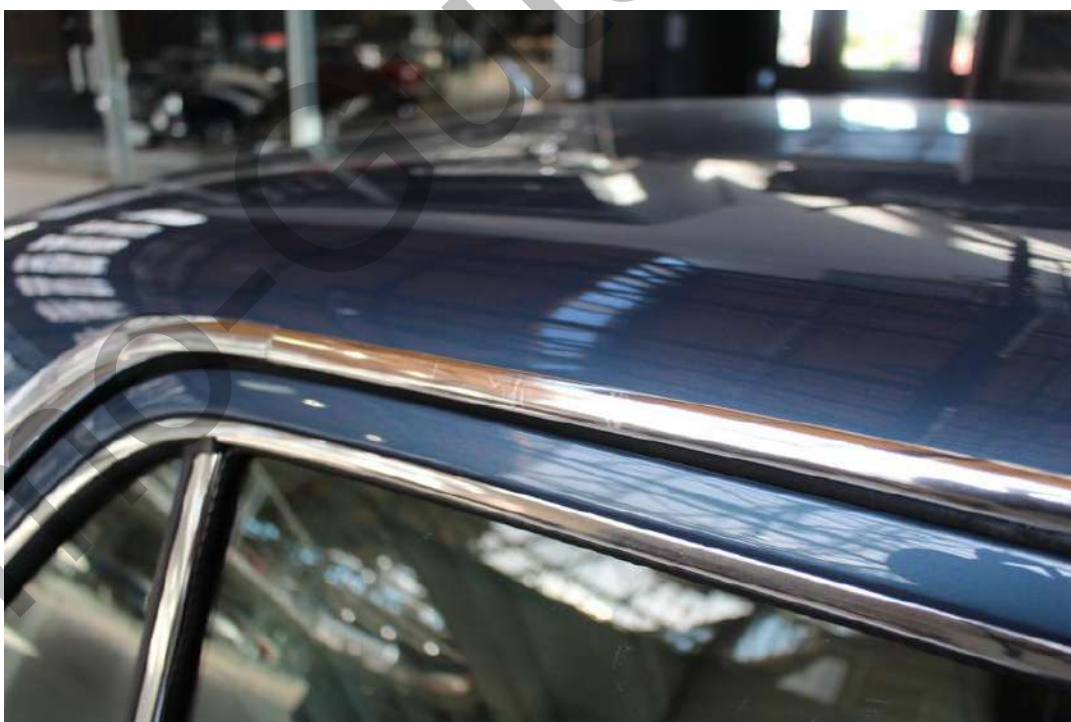
Bild 60: Mangel / Schaden – Karosserie Sicht - Dach, Kratzer

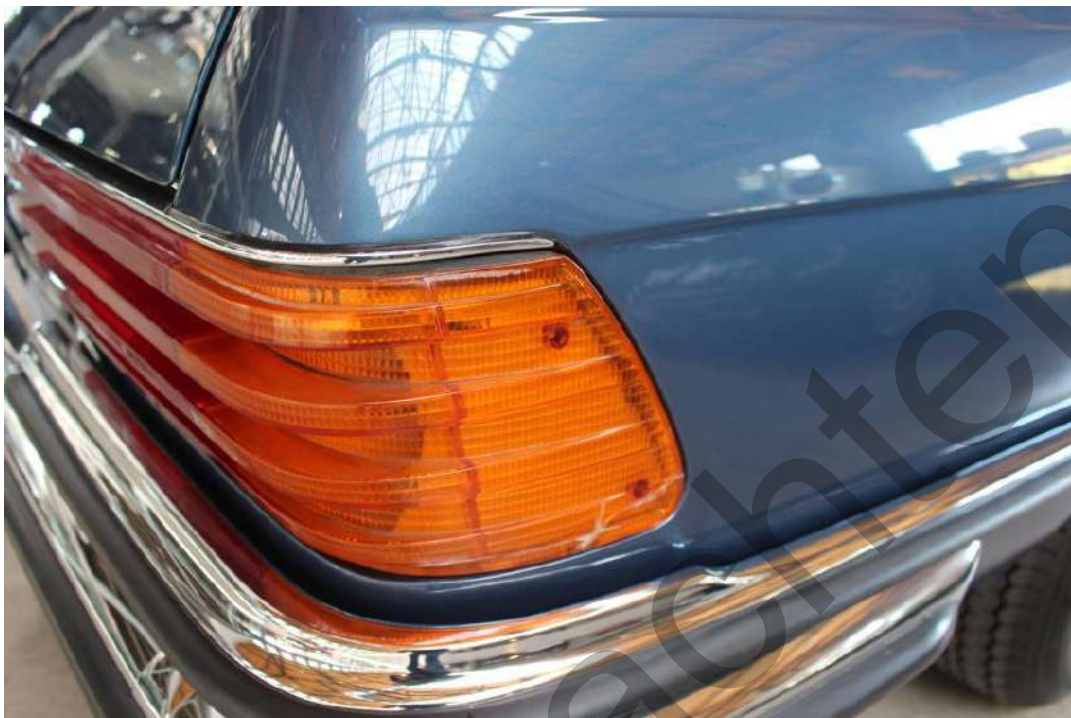
| state of the vehicle at the time of inspection - lights | |
|---|---|
| backlight | Rückleuchte hinten rechts gebrochen |

Beleuchtung - Rücklicht - schwerer Mangel - Rückleuchte hinten rechts gebrochen  
 Außen - Erkennbare Nachlackierungen - leichter Mangel - Lackeinschlüsse Silikonkrater  
 Außen - Anbauteile - leichter Mangel - Stossleisten mit Gebrauchsspuren  
 Karosserie Sicht - Stoßfänger vorn - leichter Mangel - Gebrauchsspuren  
 Karosserie Sicht - Motorhaube - leichter Mangel - nachlackiert Lackeinschlüsse  
 Karosserie Sicht - Dach - leichter Mangel - nachlackiert Lackeinschlüsse  
 Karosserie Sicht - Heckklappe - leichter Mangel - nachlackiert Lackeinschlüsse  
 Karosserie Sicht - Seitenwand-Kotflügel h. l. - schwerer Mangel - nachlackiert gespachtelt  
 Karosserie Sicht - Tür h. l. - schwerer Mangel - nachlackiert gespachtelt  
 Karosserie Sicht - Tür v. l. - leichter Mangel - nachlackiert  
 Karosserie Sicht - Kotflügel v. l. - leichter Mangel - nachlackiert  
 Karosserie Sicht - Kotflügel v. r. - schwerer Mangel - nachlackiert gespachtelt

Bild 61: Mangel / Schaden – Außen - Anbauteile, Rückleuchte gebrochen
