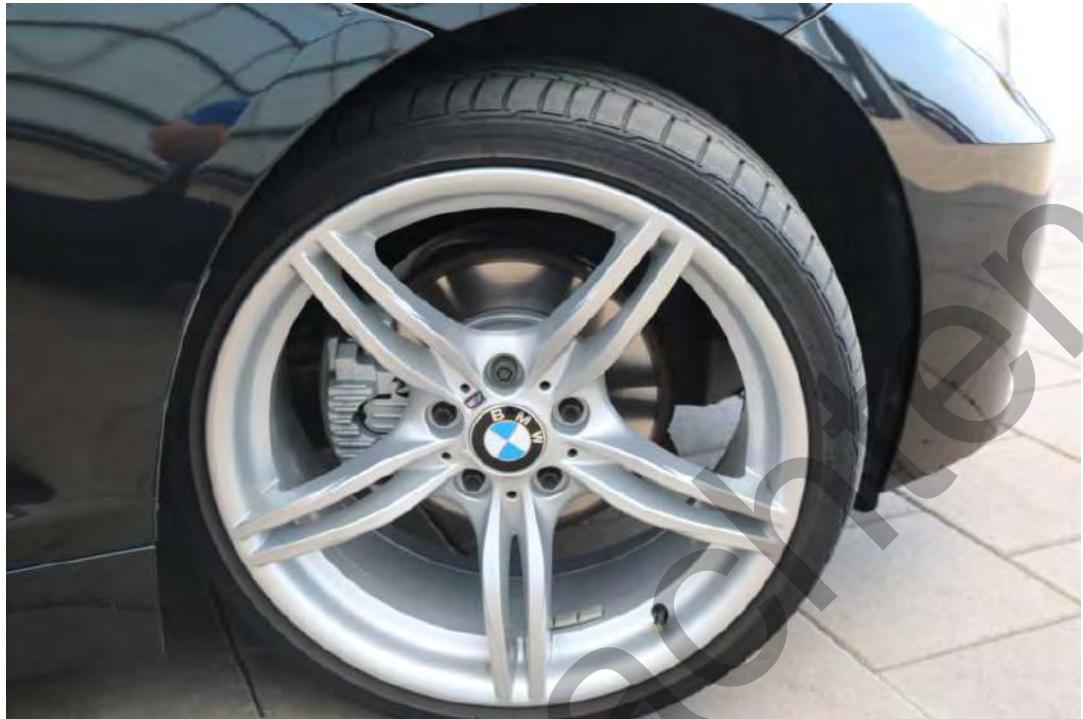
Bild 7: Felge und Reifen v. r.

Conclusion of the expert:	
The following damages were identified: Außen - Felgen - leichter Mangel - VR, VL, HR geschürft Karosserie Sicht - Stoßfänger vorn - leichter Mangel - leicht geschürft; leichter Steinschlag Karosserie Sicht - Motorhaube - leichter Mangel - Steinschlag; leichter Kratzer (poliert) No impairment of road safety was found. The vehicle possesses traces of use corresponding to the age and mileage.

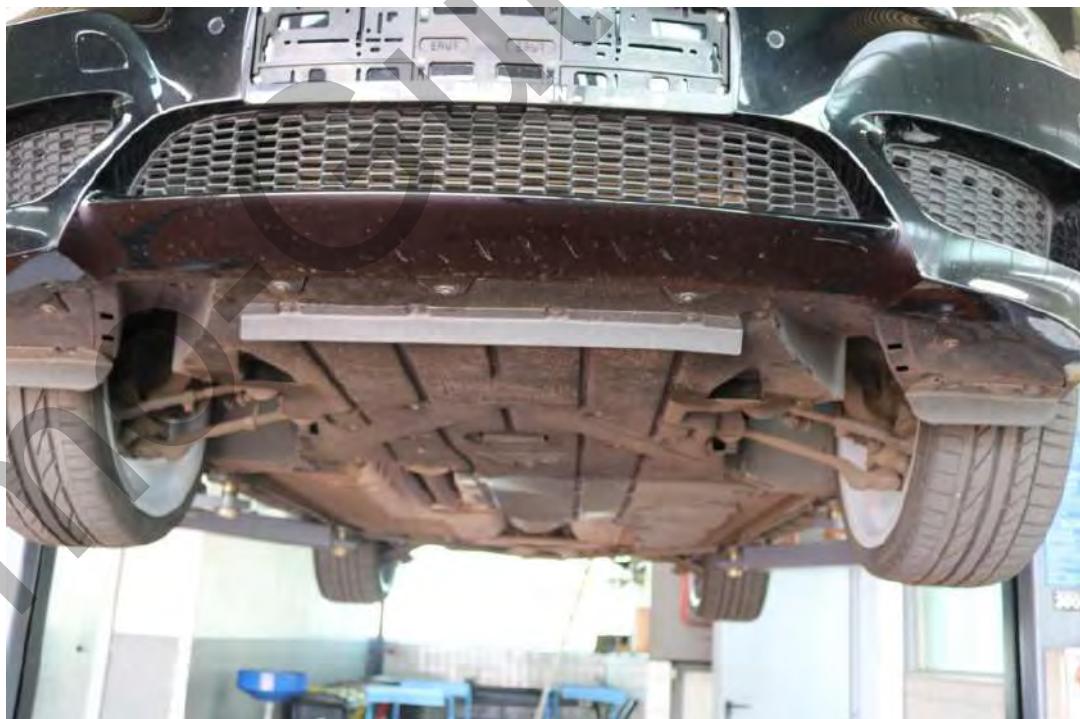
Bild 22: Unterboden

Depreciation / repair costs			
Designation / type of repair	remark	Estimated cost of repair	Decreased value
Seitenwand-Kotflügel h. l.		€50.00	
Seitenwand-Kotflügel h. r.		€50.00	
Unten Sicht (soweit prüfbar) - Bremsscheiben - leichter Mangel - leichte Rillenbildung / Rostansatz	behebt sich durchs fahren		€0.00
