| vehicle | | | | | |
|---|---|---|---|---|---|
| vehicle identification number (VIN) | WBALM31000E4546 | producer | BMW | model | Z4 |

| Conclusion of the expert: |

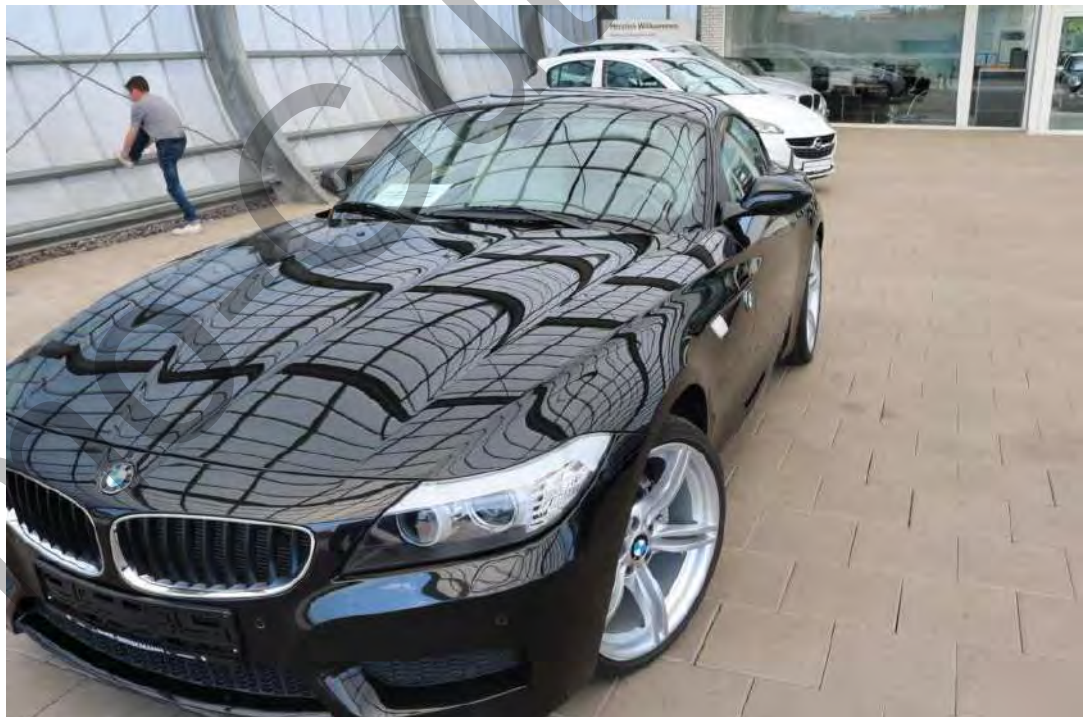
Bild 4: Frontdiagonale links

| existing / known accident damage |
|---|
| The following traces of accidents were found:<br>Seitenwand-Kotflügel h. l. - reparierter Unfallschaden<br>Tür v. l. - reparierter Unfallschaden<br>Kotflügel v. l. - reparierter Unfallschaden |

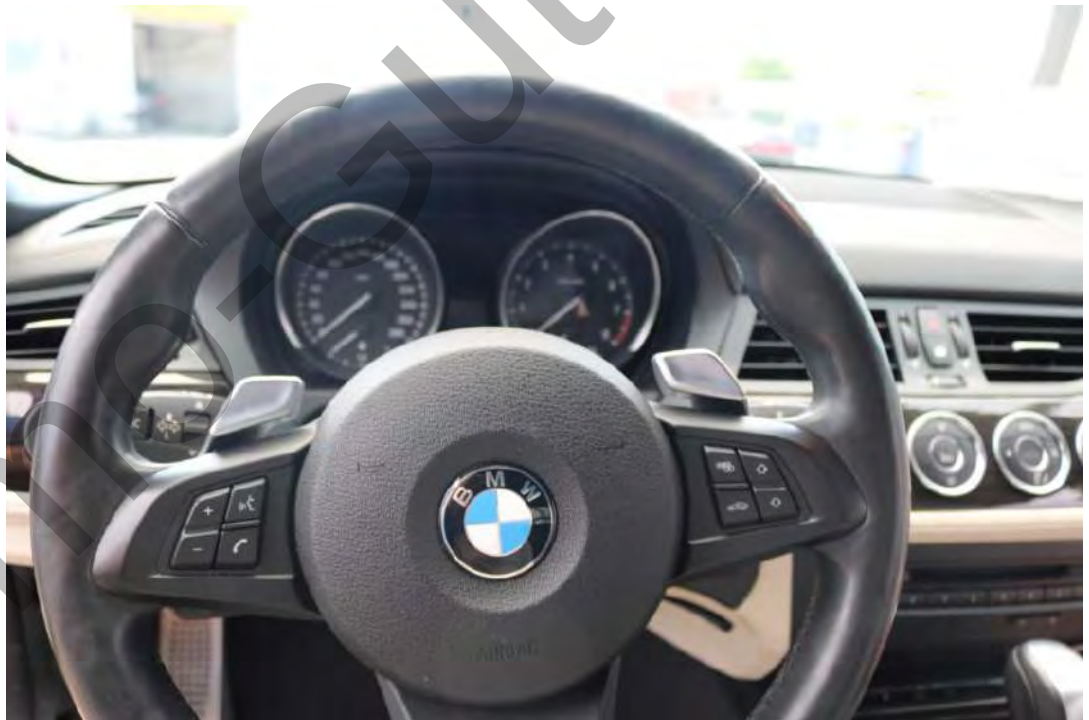
Bild 16: Instrumentenansicht

| error in instrument cluster |
|---|
| No failures were displayed in the electronic instrument cluster. |

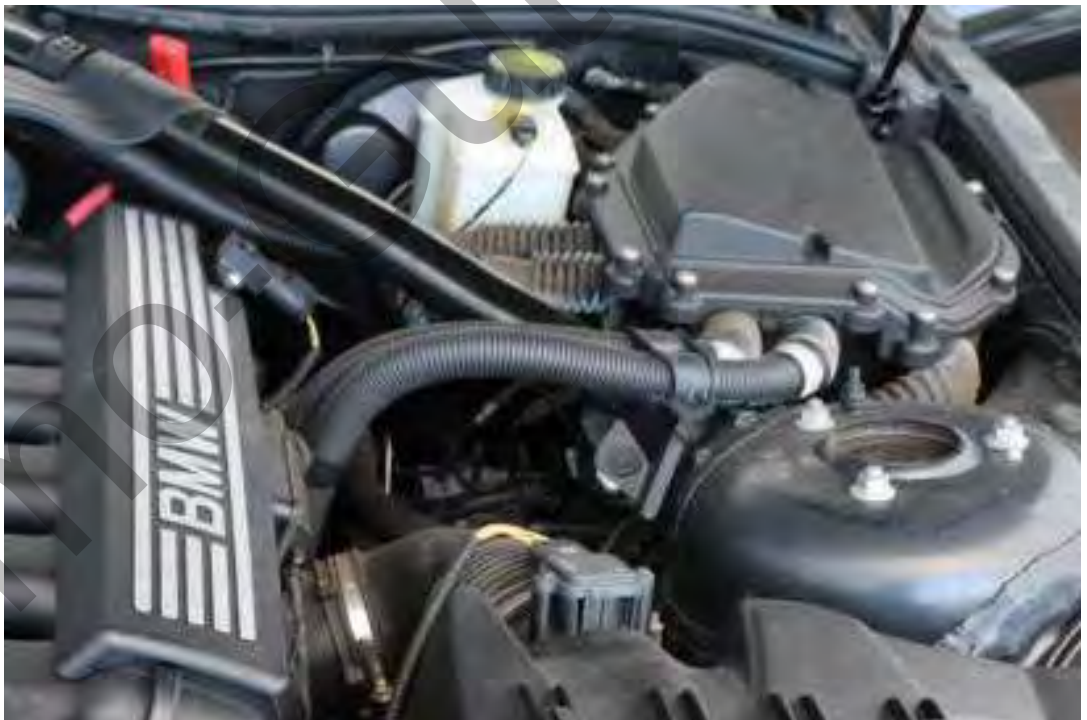
Bild 40: Ölzettel – nicht vorhanden
